Montana Department of Transportation
Research Program
February 2002

RESEARCH CONSTRUCTION REPORT

Thin-Whitetopping Overlay Composite

Project No.: STPP 20-1(6)0 P-20, Highway 16

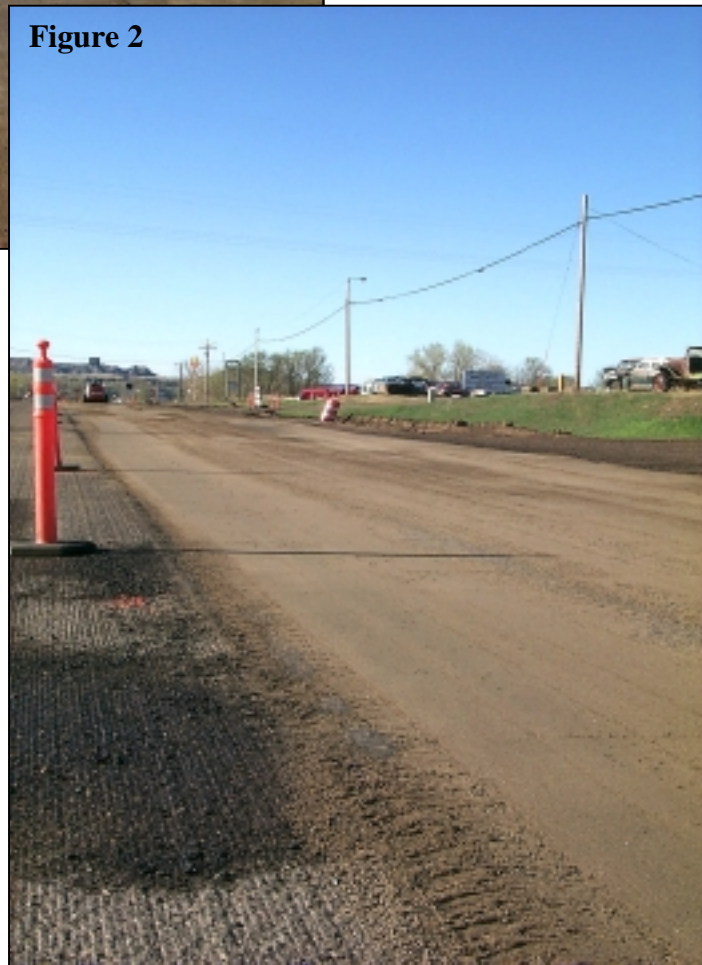
Figure 2

corings showed an insufficient layer of AC. The old AC layer needed to be built up to adequately support the PCCP layer. Plant mix asphalt was laid down at an average approximate depth of 50 mm (2 inches). To assure a rough surface for PCCP placement, sand was placed to allow traffic to wear the surface to insure adhesion of the whitetop (figure 2).

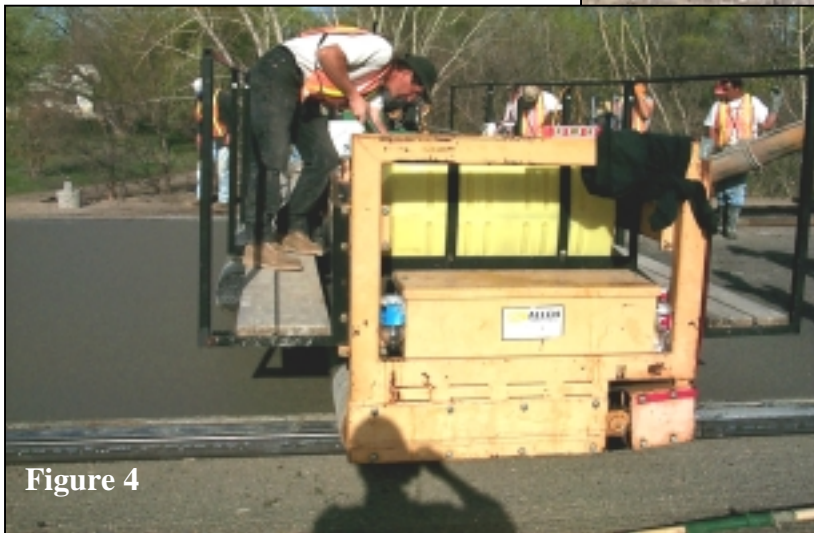
Figure 4

Once the forms were installed and correctly aligned, the contractor set the paver onto the forms to begin paving. The paver used was an Allen Three-Tube Roller Paver (figure 4). The action of the paver was a back and forth motion, with each forward motion the unit would advance several feet. Unfortunately, (as seen in figure 5) the weight of the paver crushed the metal forms. Once this happened, paving was discontinued and the paver removed from the roadway.

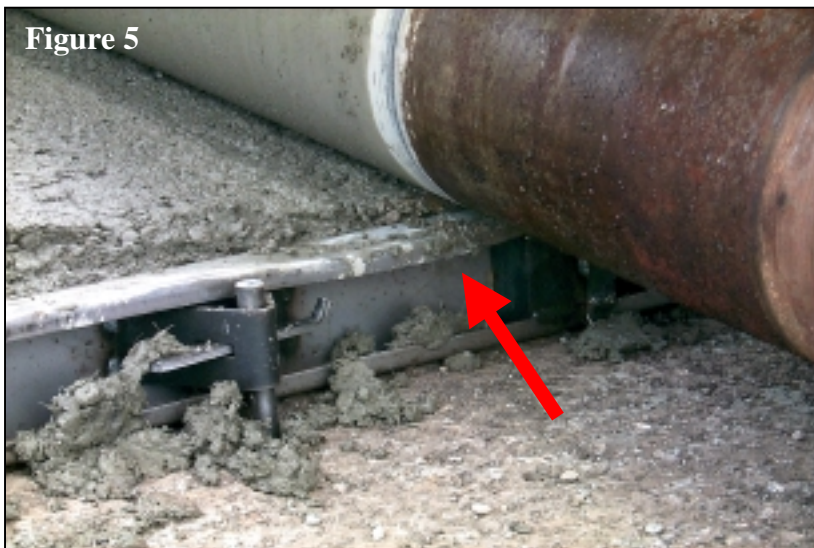
Figure 5

The (estimated) 6-7 yards of concrete could not be competently placed and was subsequently removed from the pavement.

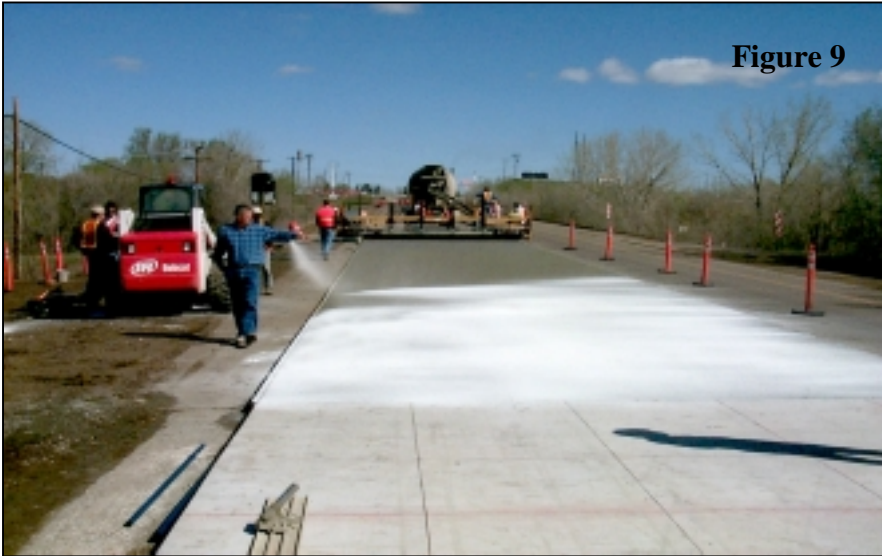
yellow arrows) being used to consolidate the concrete. The contractor did a good job in pacing the consolidation with the speed of the paving. Once the concrete was placed, curing compound was applied to prevent premature curing. Figure 9 shows Greg Miller of Holcim Inc. (formerly Holnam) instructing the contractor on the correct application of compound on the finished concrete. Figure 10 is how the contractor was applying the cure the following day. There were noticeable gaps in coverage. It was difficult to impress upon the contractor the critical aspect of applying adequate cover to the fresh concrete. A special provision had even specified a double shot to insure sufficient coverage. This procedure was discussed in several meetings with the contractor prior to and during the start of the project. This may result in premature cracking and reduce the

life of the pavement. This reviewer was not present during the southbound lane construction, and is unsure if this application practice was continued throughout the completion of the project.

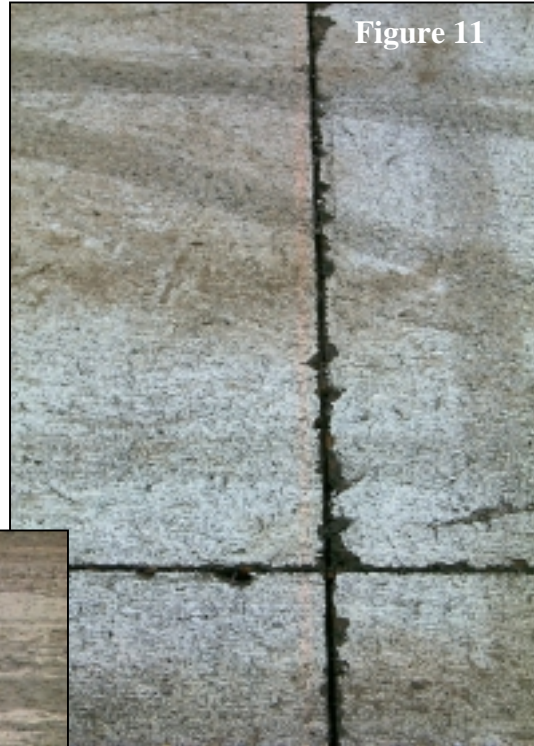
Once the PCCP had cured sufficiently, the saw team began cutting the joints with an average spacing of 1.2 meters minimum and 1.5 meter maximum. Cutting width averaged at 3 mm with an average depth of 25 mm. There seemed to be an inordinate amount of spalling at the

joints while cutting. There was speculation that the polypropylene fibers were the cause of this spalling. Although there was various saw spalling during the Kalispell whitetopping project, there seemed to be substantially more for this project (as observed on the southbound lanes). It is assumption only, but this excessive spalling may be from the result of cutting into too green of concrete. Timing of the cuts is critical for this type of pavement application. The spalling is unsightly, but should not interfere with the performance of the whitetop. Figure 11 is a sample image of the saw cut spalling.

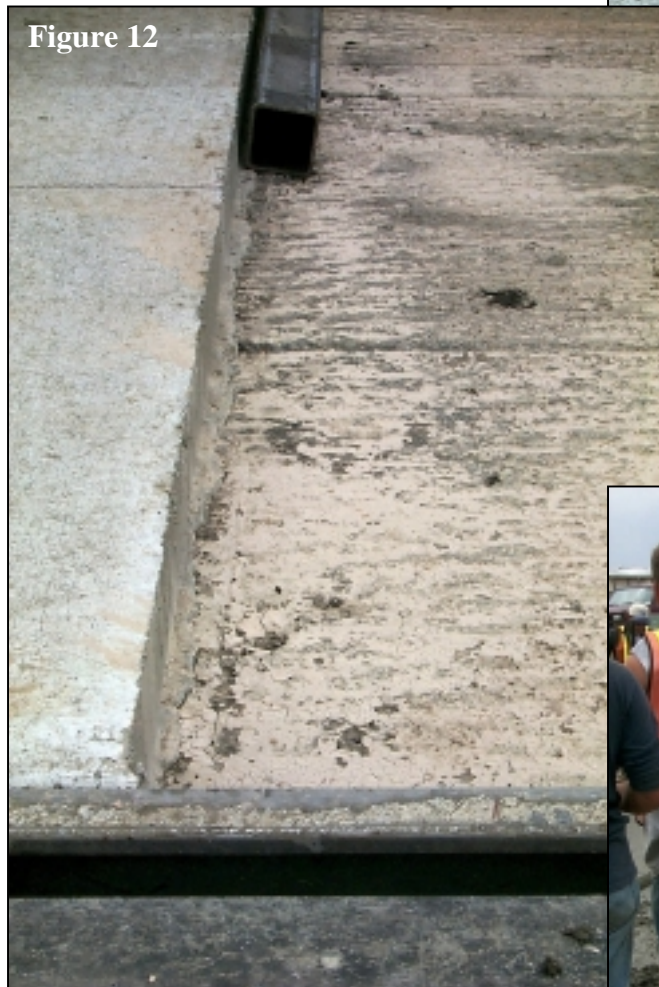
Another concern from the sawing process was the slurry residue resulting from concrete dust being washed from the whitetop onto the milled asphalt surface. The contractor felt it was unnecessary to remove this waste product from the AC surface on a daily basis. It was explained to the contractor on the necessity of having a clean dry surface for the PCCP layer to bond with the AC layer. The contractor stated that the slurry debris was concrete paste and there was no concern about sufficient bonding. In turn, it was explained to the contractor that the slurry was dust created from the sawing

of joints, and the dust had no hydration or exothermic reaction to represent un-cured Portland cement. Basically, it was dirt, and of sufficient thickness and friability to be a detriment to that section of

pavement. Figure 12 is an example close-up of the slurry wash on the milled AC. It was not observed if the contractor eventually complied with this request. Figure 13 is a view of the southbound PCCP being placed on the AC with slurry residue.

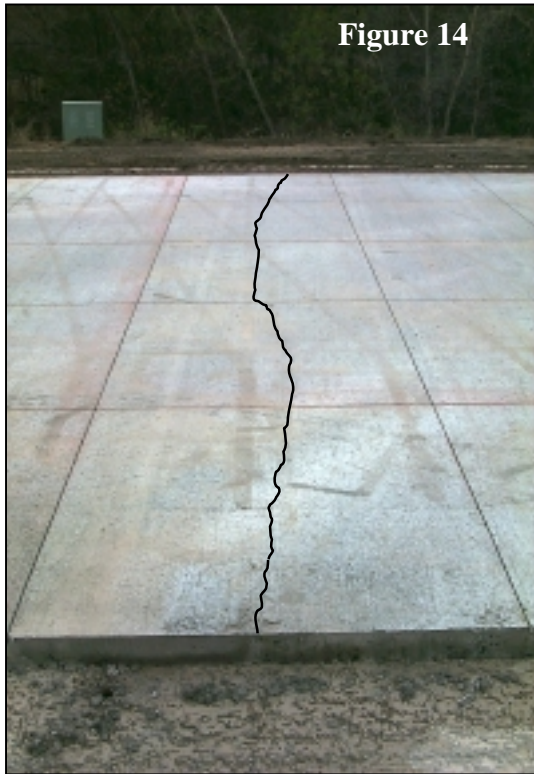
Transverse cracking on the southbound lane appeared soon after the PCCP had cured. Speculation on the part those individuals who had witnessed the construction gave reasons of poor curing which may have created shrinkage cracking or late timing with the

joint cuts. In addition, if the bond between the two layers is compromised the load transfer may also cause premature cracking. Figure 14 & 15 are examples of cracking observed. Lines have been superimposed over the image to better view the lay of the crack.
